Active Landslides on Slopes of Selbukhra Mountain, Southwestern Crimea, Ukraine

E.A. VOZNESENSKY, N.V. KUMACHYOVA
E.N. SAMARIN, M.Yu. NIKITIN

Loess Landslides Triggered by Irrigation on the Slopes of the Terrace Edge in Heifangtai of Yongjing County, Gansu Province, China

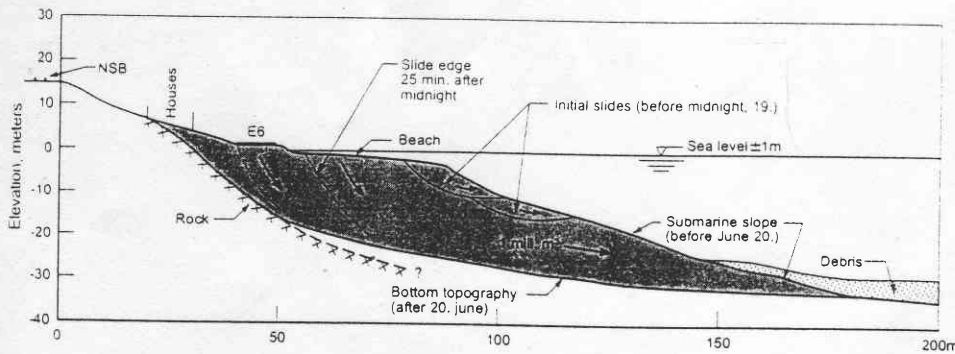
Fig.2 Key sketch to illustrate the sliding mechanism

surface cracks and into open slits between the steep rock face and the soil, and possibly water-main leakage, all of which could lead to seepage toward the unprotected submarine slope.

However, it is important to stress that stability analyses showed that the beach slope had a low margin of safety, perhaps less than 10% (i.e., $F < 1.10$). Thus any man-made activity, or nature-induced cause, amounting to a 10% safety reduction could have triggered the initial slides.

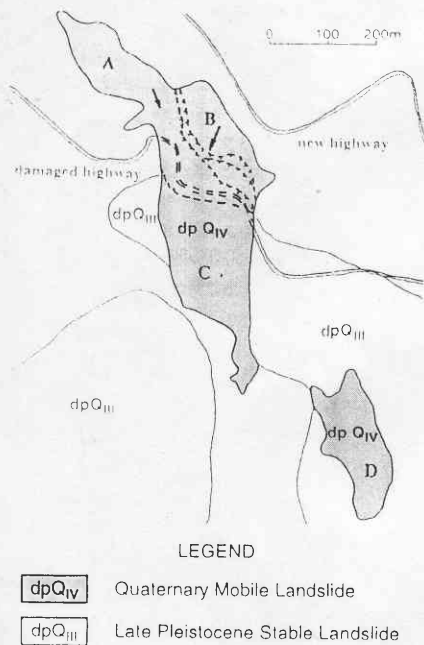
Fig. 2 Schematic landslide map of the area: dpQIII - Late Pleistocene stable landslide, dpQIV - mobile landslides

Morphologically, the slope represents a broad ancient concave flow surface, conical in shape, widening toward the top of Selbukhra Mountain. This shape captures all precipitation along the northern slope of the mountain. Both margins of this surface are confined by ancient (Late Pleistocene) landslides, partly cut by erosion and thus not distinct in present relief under a cover of Holocene diluvium. These are relatively large blocks, quite stable now, but with minor active flow slides on their surface (area D of Fig. 2).

But the most active portion of the landslide, that responsible for the highway damage, is part B. As can be seen from Fig. 4b this is a retrogressive slide. Rigid blocks of Late Albian sandstones are moving downslope, squeezing the underlying Aptian clays. The roof of these clays is moistened by ground water, draining at the base of relatively permeable sandstones. Thus, the main scarp is constantly "retreating" backward toward the new highway. Rows of these tilted blocks are separated by the concentric minor scarps shown in Fig. 2. This retrogressive part of the landslide moves at a sharp angle to the direction of head creep (shown in Fig. 2 by an arrow).

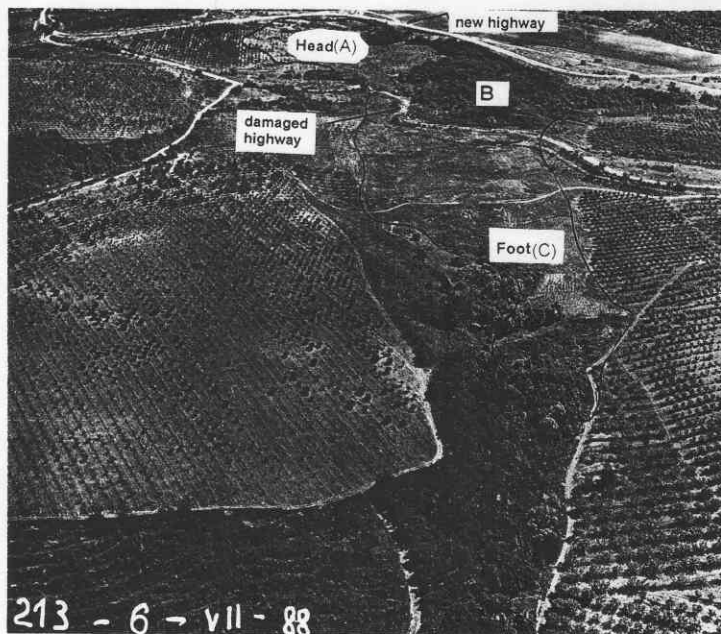
Fig. 3 Aerial view of the landslide area.

several settlements to the city of Simferopol. The most dangerous is the landslide shown in Figs. 3 and 4, the largest and longest-existing one. In its structure, several generations of movement can be separated. This landslide has a specific glacier-like shape. Its length from the tip to the crown (we are using nomenclature for landslides recommended by IAEG Commission on Landslides (1990)) is about 800 m, with a maximum width of 190 m. The most disastrous event took place during the spring of 1980, after a very snowy winter and rapid snow melting resulted in destruction of the highway. Parts of the highway were driven downslope for several tens of meters. This landslide has a complex structure and consists of three main parts (Figs.3, 4).

The major part is the landslide foot (area C), which makes up about 40% of the total landslide area. This is a stable portion consisting of several mostly ancient landslides, partly overlying each other. The boundaries between these ancient landslides coincide with bars several meters high, built of clays protruded from the frontal part of each succeeding generation of the landslide at the final stage of its movement. Mobile parts of the landslide consist of the two parts A and B.

The head (A) occupies an orchard area and its crown is located only a few meters from the new highway. The situation is critical because two minor, mobile landslides have recently appeared on both sides of the road here. A cross section of the landslide head was studied by excavation of a pit about 2 m deep; the section was composed of brown and brown-gray clays. Small half-rounded fragments of marl debris from Late Cretaceous rocks found in these deposits provided evidence of their diluvial origin.

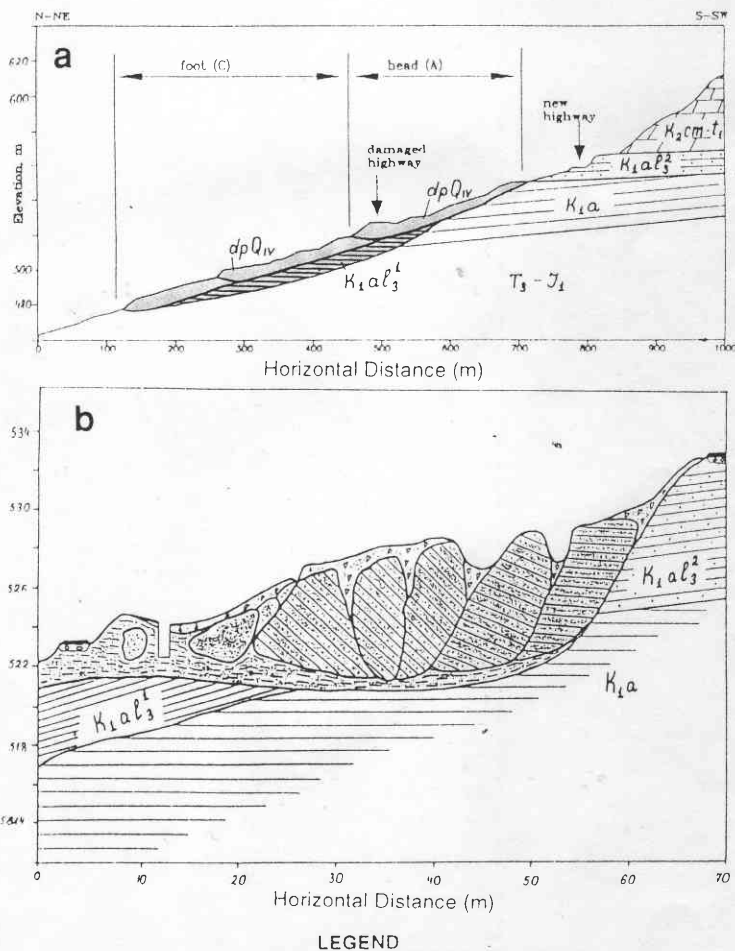
Fig. 4 Cross sections through mobile parts A and B of the landslide. a) Longitudinal section of parts A-C, b) Transverse section of parts B-C.

rupture of clays is the mechanism controlling the slide development as a whole; however, rates of deformation and rock sliding volumes differ substantially between the two parts.

To evaluate the hazard and recommend means of mitigation, the following problems should be solved: 1) identification of the depth of the rupture zone (we believe this is

not a distinct surface) under the retrogressive slide along its axis, and 2) evaluation of the probability of the stable part activation as a result of the accumulation of overlying mass.

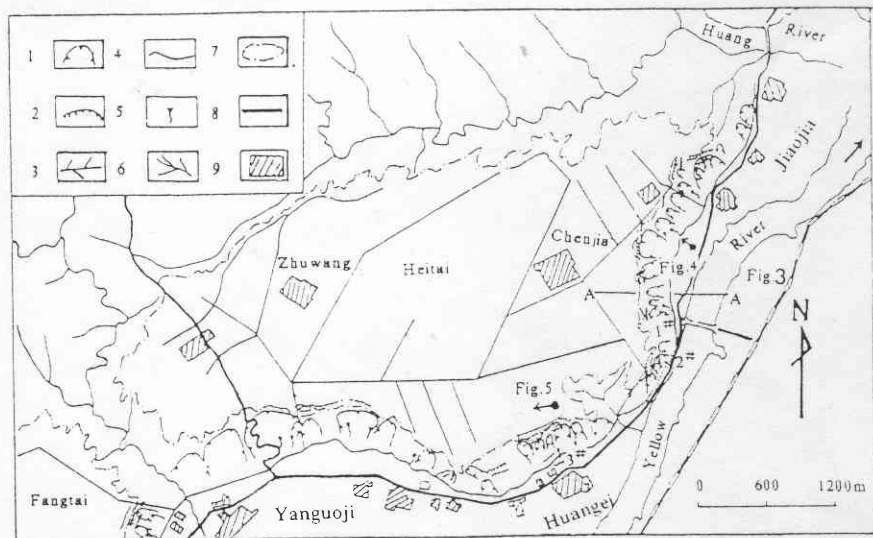
Fig. 2 Distribution map of landslides at Heifangtai. Legend: 1. Landslide, 2. Fissure, 3. Ditch on terrace, 4. Ditch at foot of terrace, 5. Spring, 6. Gully, 7. Divide of terrace, 8. Highway, 9. Village.

landslides are connected to each other, and form a large-scale landslide group. Based on landform, the landslides can be divided into three zones from east to west (Fig. 2):

Landslides have frequently occurred in this zone. There are 18 landslides along 3 km-long terrace edge. Most recent landslides in this zone have been of the high-speed avalanche type. On 15 March, 1989, one $6 \times 10^4 \text{ m}^3$ landslide slid from a 150-m-high steep slope in several minutes. The slide destroyed 50 m of irrigation ditch and 50 m of highway foundation. After that, the sliding mass moved into the Yellow River and caused huge waves, which submerged 2 ha of farmland on the opposite shore (Fig. 2). During 1992 and 1993, five landslides occurred in this zone (Fig. 4).
